Debris/Ice/TPS Assessment and Integrated Photographic Analysis Of Shuttle Mission STS-100

**DEBRIS/ICE/TPS ASSESSMENT
AND
INTEGRATED PHOTOGRAPHIC ANALYSIS
OF
SHUTTLE MISSION STS-100**

April 19, 2001

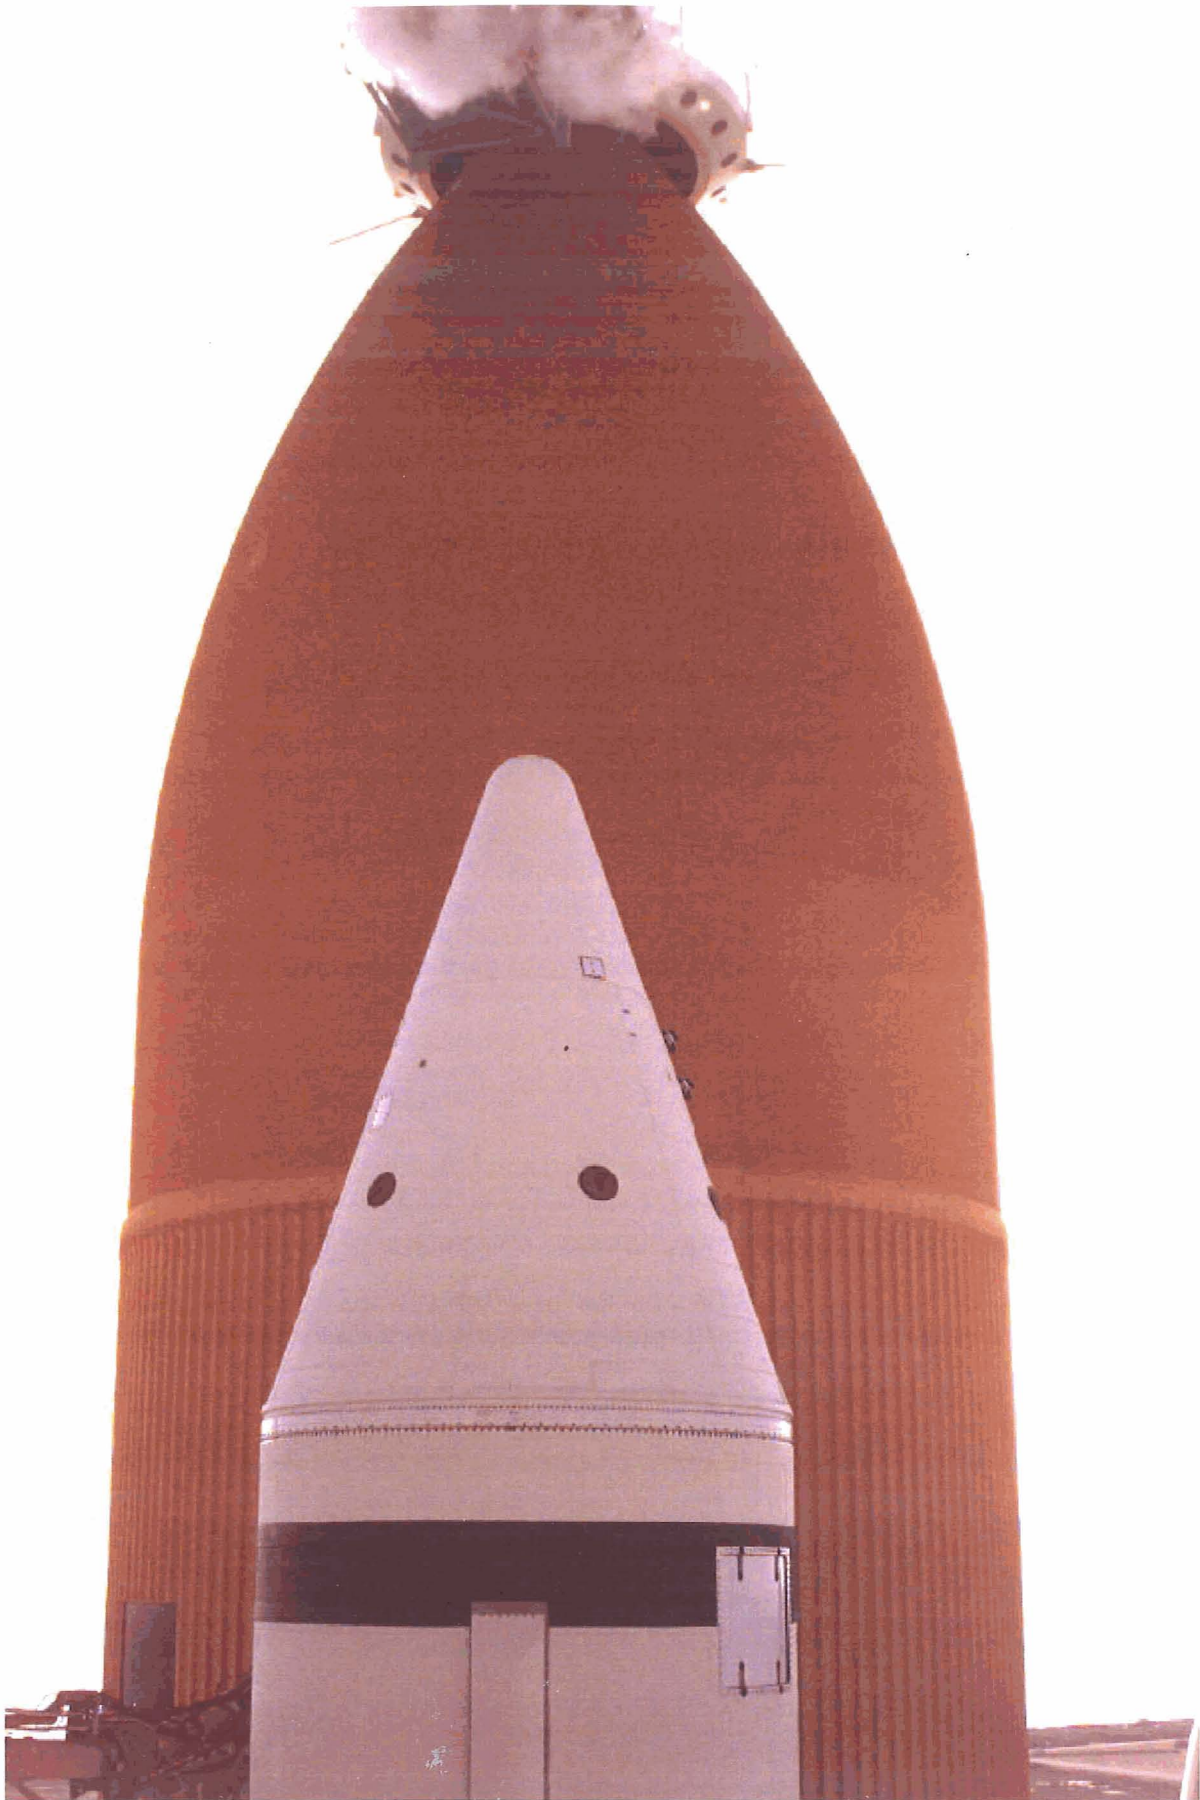
Photo 2: LO2 tank acreage.

No condensate was present on the LO2 tank acreage. Surface temperature ranged from 39 to 56 degrees Fahrenheit. There were no acreage TPS anomalies.

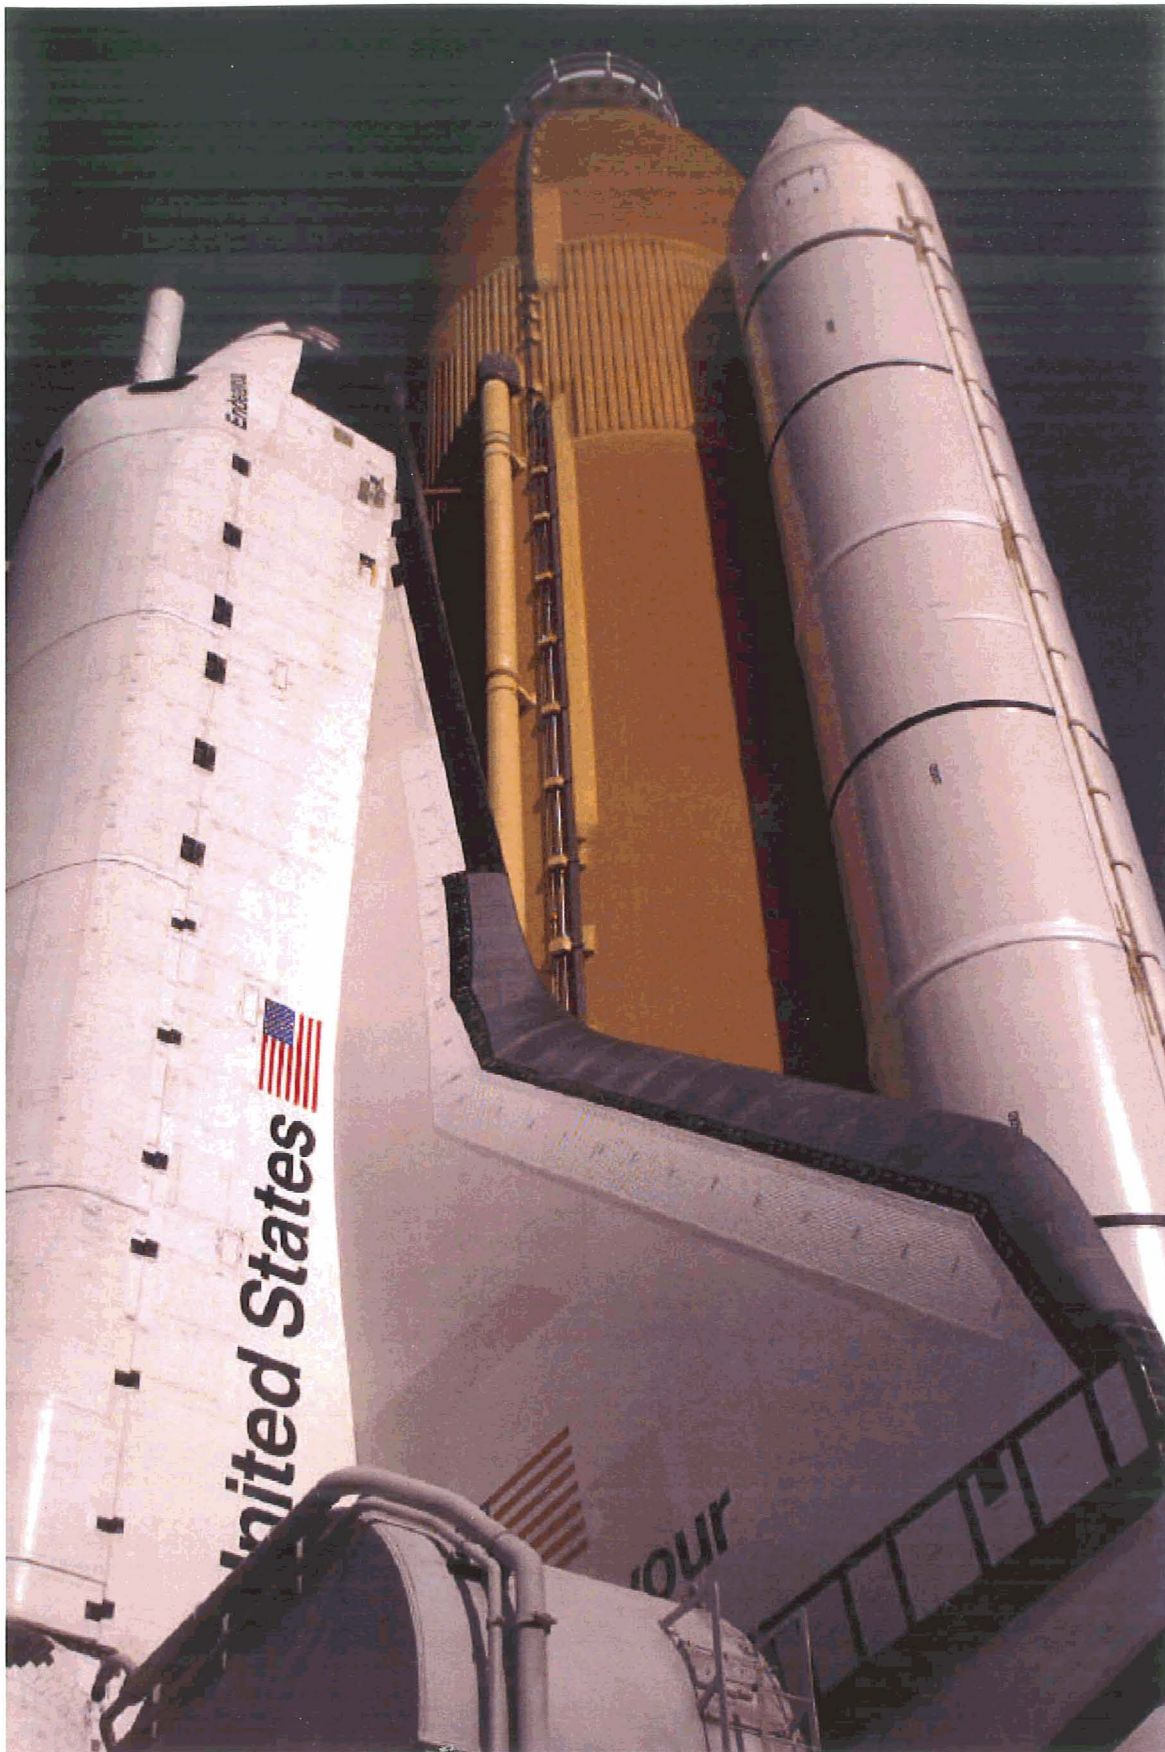
Photo 3: LH2 tank acreage.

No condensate was present on the LH2 tank acreage. Surface temperature ranged 45 to 56 degrees Fahrenheit. There were no acreage TPS anomalies.

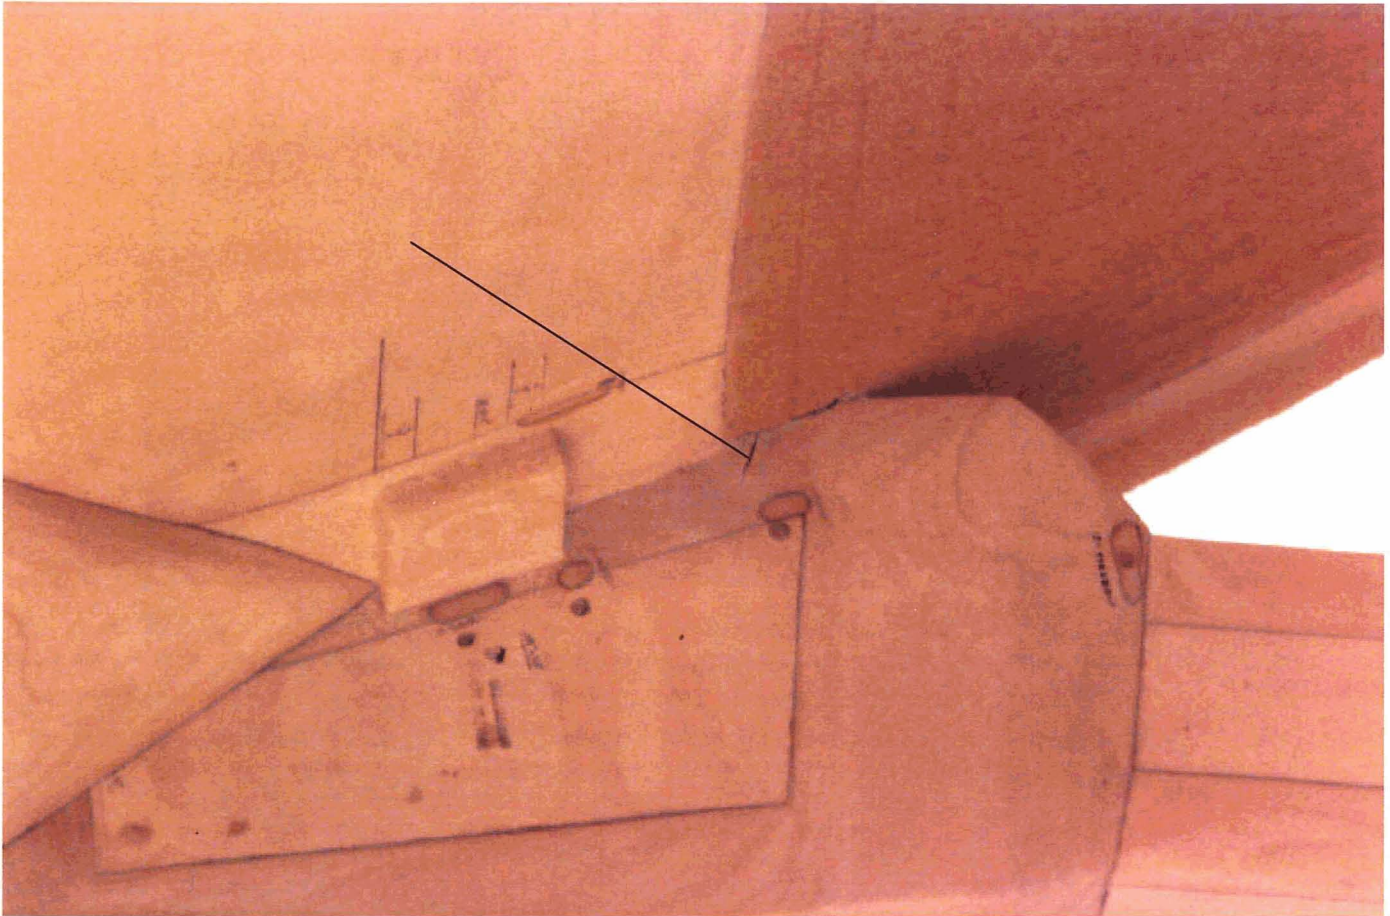
Photo 4: Crack in -Y Vertical Strut TPS

A 4-inch in length and .25 inch wide stress relief crack was observed in the -Y vertical strut TPS with no offset. This condition has been observed on previous vehicles and found acceptable for flight per the NSTS-08303 criteria.

A 4 inch long and 0.25 inch wide stress relief crack was observed in the -Y vertical strut TPS with no offset. This condition has been observed on previous vehicles and found acceptable for flight per the NSTS-08303 criteria.

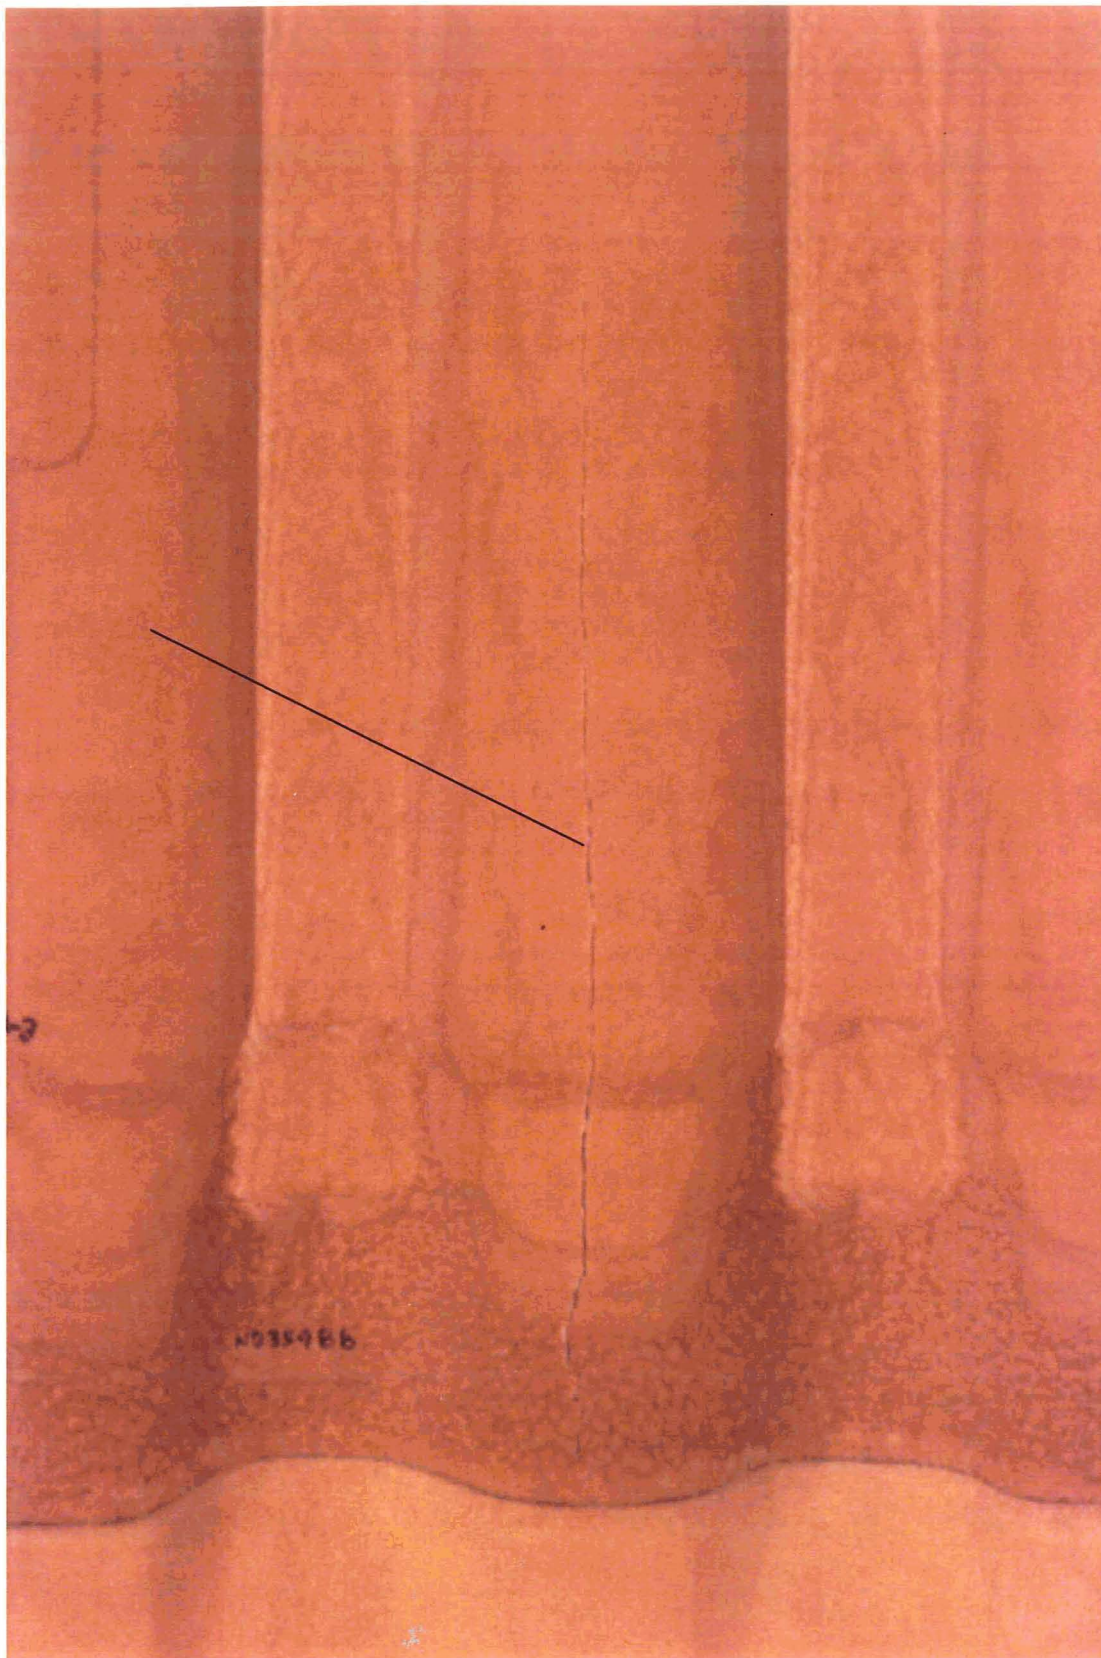
Photo 5: Cracks in Intertank Stringer Valleys

No significant anomalies were present in the intertank TPS. A total of seven cracks in the intertank stringer valley TPS were observed (-Y/-Z side and -Y/+Z side). None of the cracks exhibited ice, frost, nor offset. Therefore, the cracks were acceptable for flight per the NSTS-08303 criteria. Ice and frost accumulations on the GUCP were typical.

No significant anomalies were present in the intertank TPS. Seven stringer valley TPS cracks were observed (-Y/-Z side and -Y/+Z side).

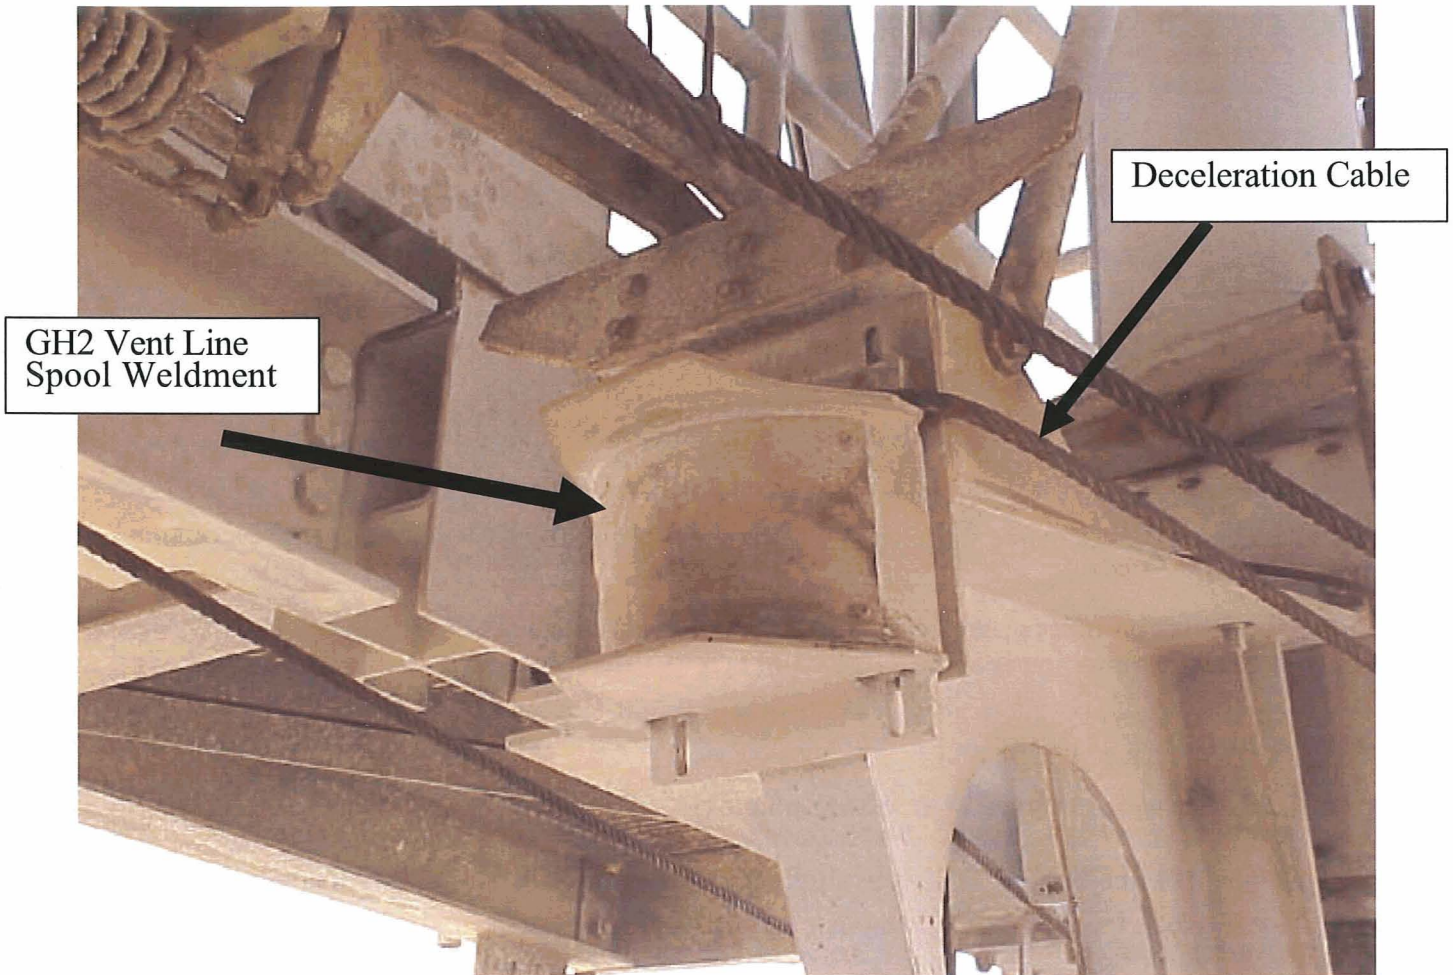
Photo 6: GH2 Vent Line Latch-back

The GH2 vent line latched in the eighth of eight teeth of the latching mechanism. The deceleration cable failed to catch the spool weldment, no damage was noted (IPR PAD A-21771). Subsequent troubleshooting could not determine a root cause of the anomaly and the IPR was closed as an unexplained anomaly. The GUCP 7-inch QD sealing surface exhibited no damage. A detached metal ID ("dog tag") was found around the GUCP purge QD's.

Deceleration cable failed to catch the spool weldment, no damage was noted.

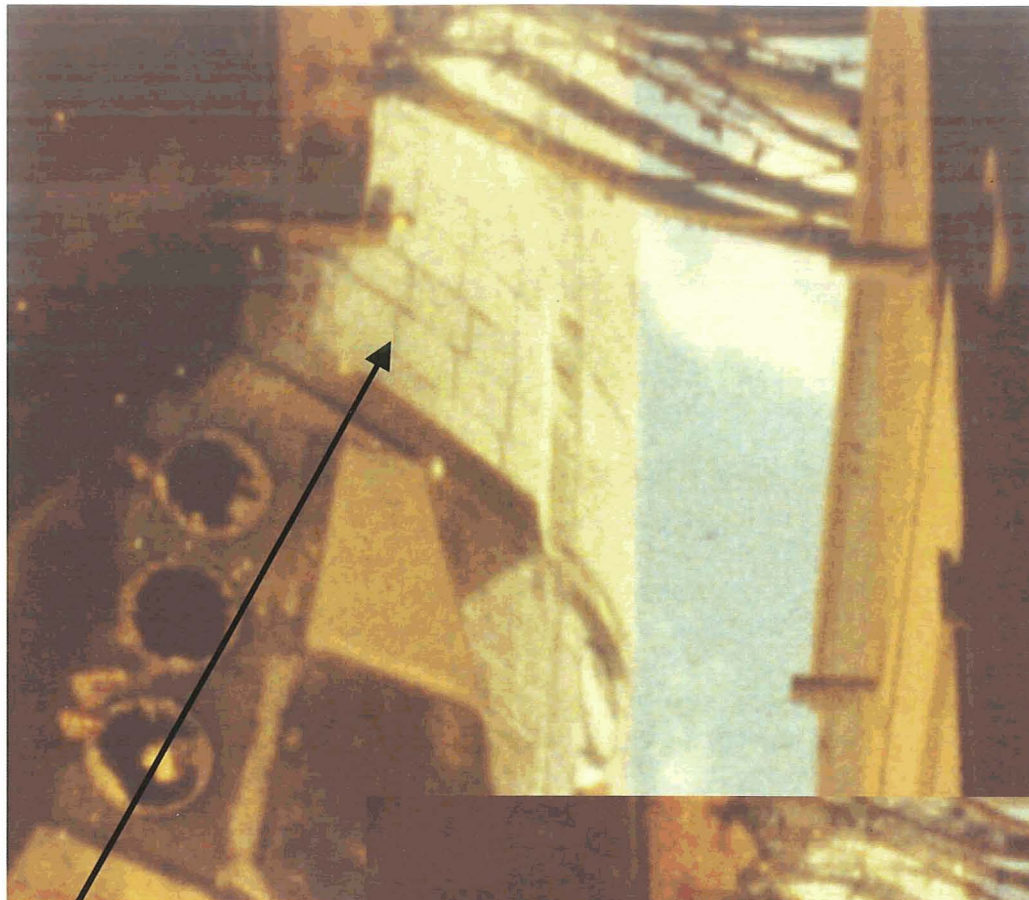
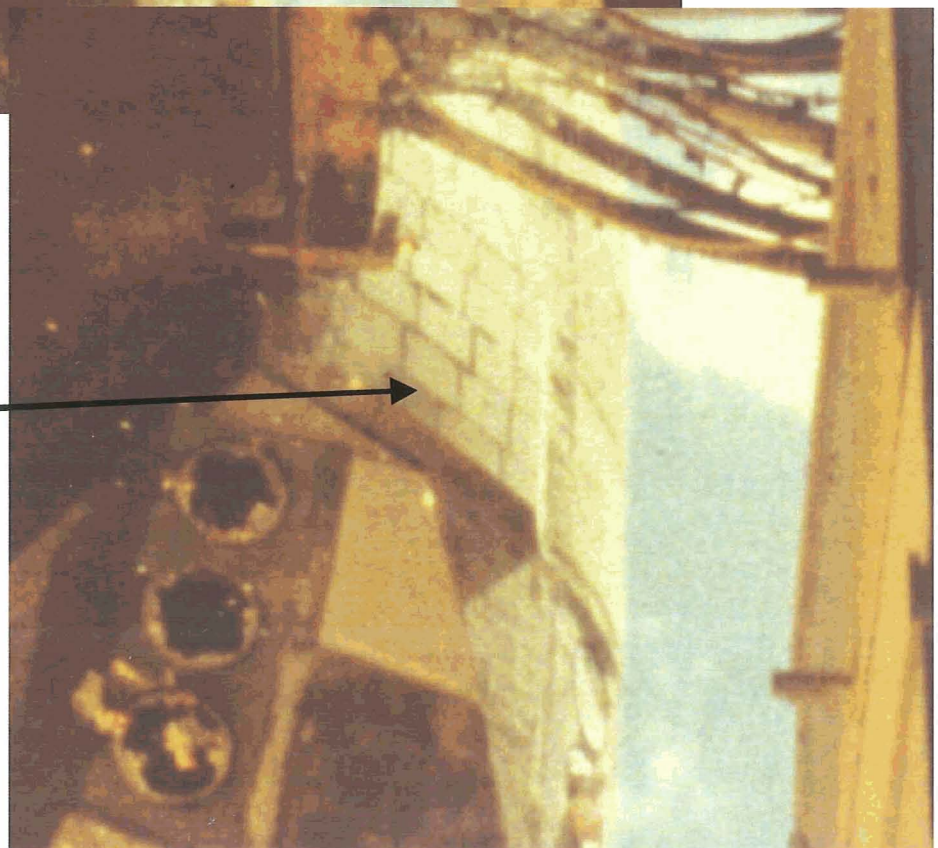
Photo 7: LH OMS Pod TPS Motion

The only anomalous condition observed during the Film Review was the apparent motion of the lower Left Hand OMS Pod TPS. MLP camera, E-18 captured the motion during SSME startup. The event begins at 109:18:40:38.386 UTC and seems to last for approximately 0.5-second. A similar motion, but substantially less in magnitude can be observed on the RH OMS Pod TPS. This event was reported to the Mission Management Team, Shuttle managers, vehicle systems engineers, and to Program Integration.

The movements noticed on STS-94, STS-98, and the RH OMS Pod on STS-100 were of significantly less magnitude than that of the LH OMS Pod on STS-100.

Observed
motion in the
OMS POD in
this area.

Apparent motion observed on lower LH OMS Pod TPS surface.

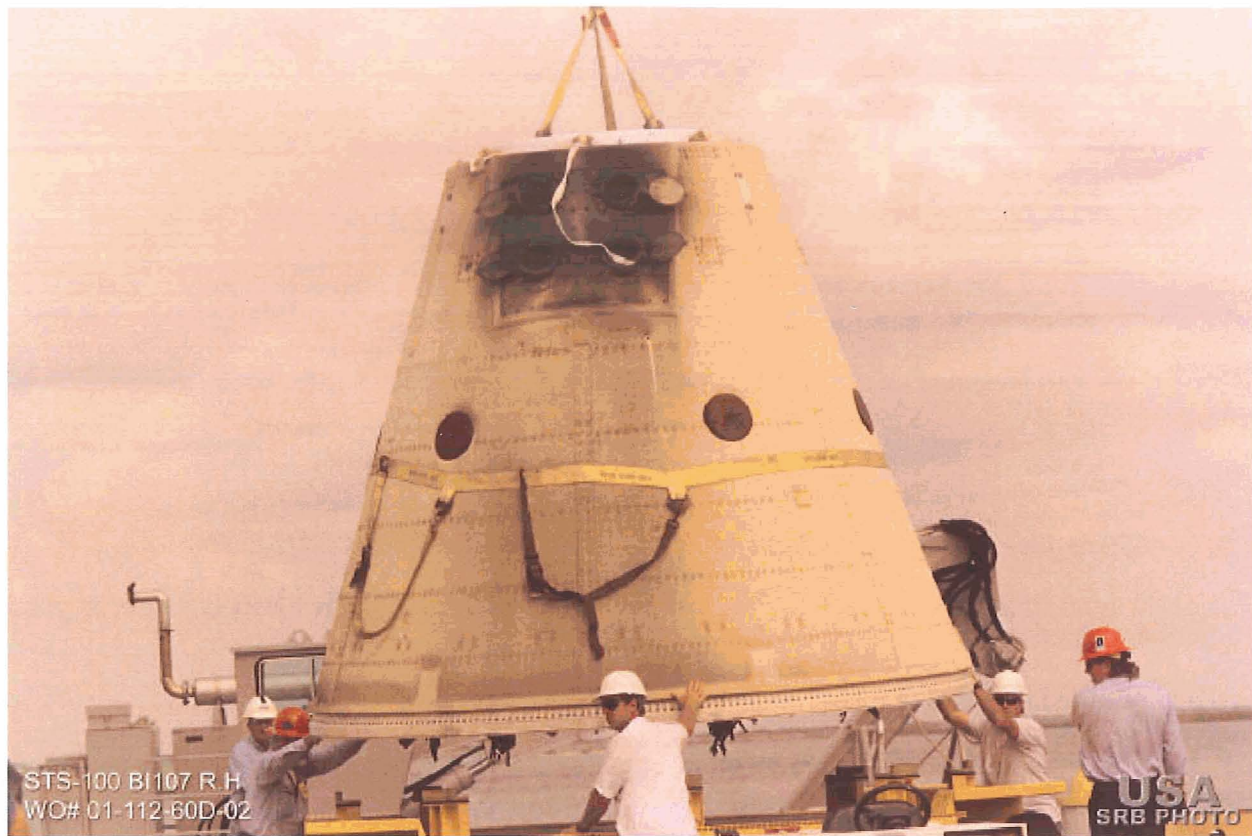
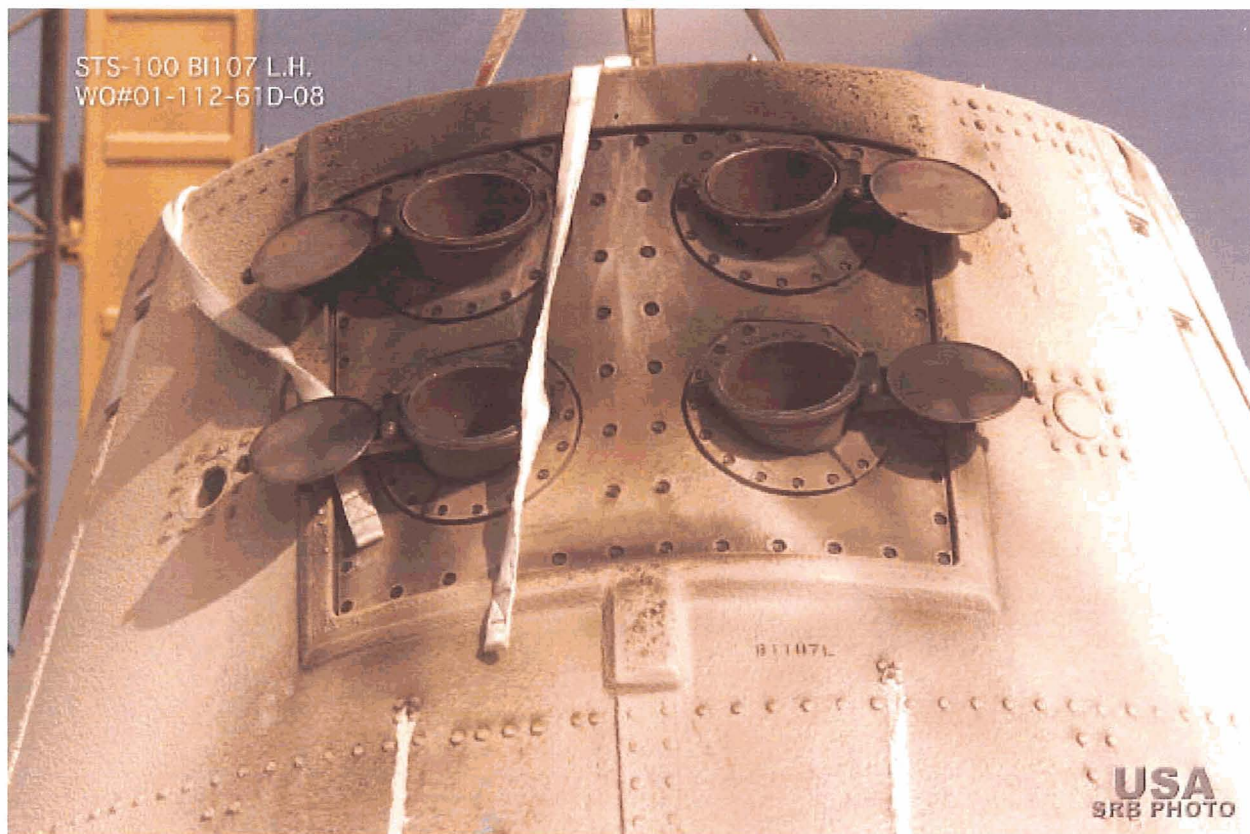
Photo 9: Frustum Post Flight Condition

The frustums exhibited no debonds/unbonds or missing TPS.
All eight BSM aero heat shield covers had locked in the typical opened position.

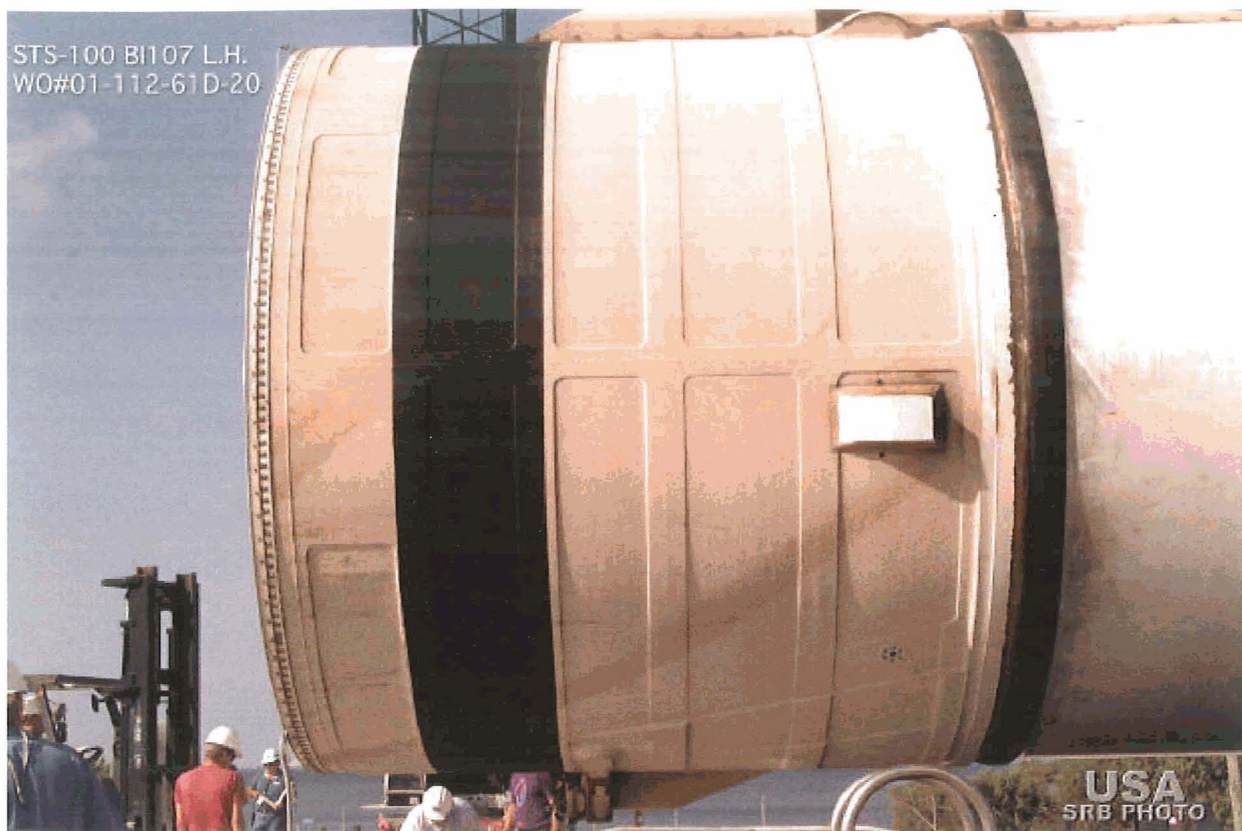
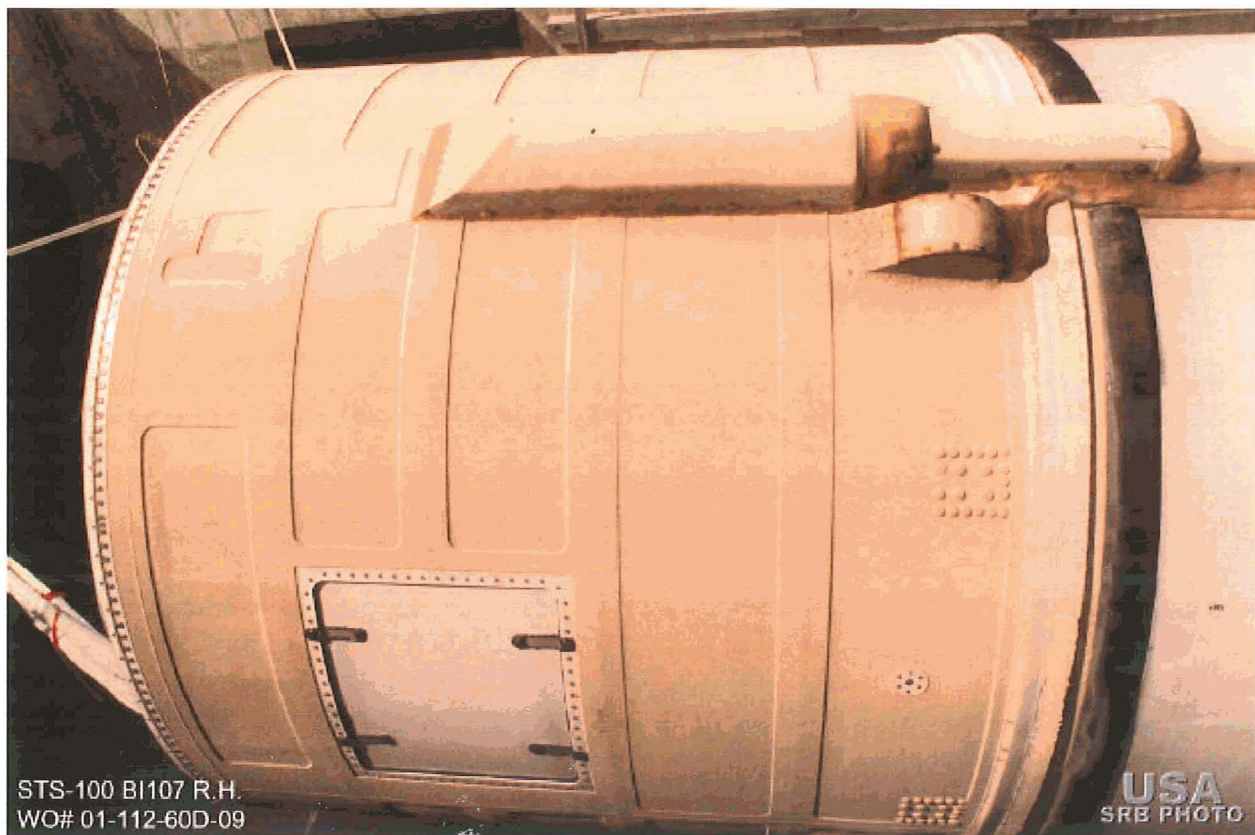
Photo 10: Forward Skirt Post Flight Condition
The forward skirts exhibited no debonds or missing TPS.

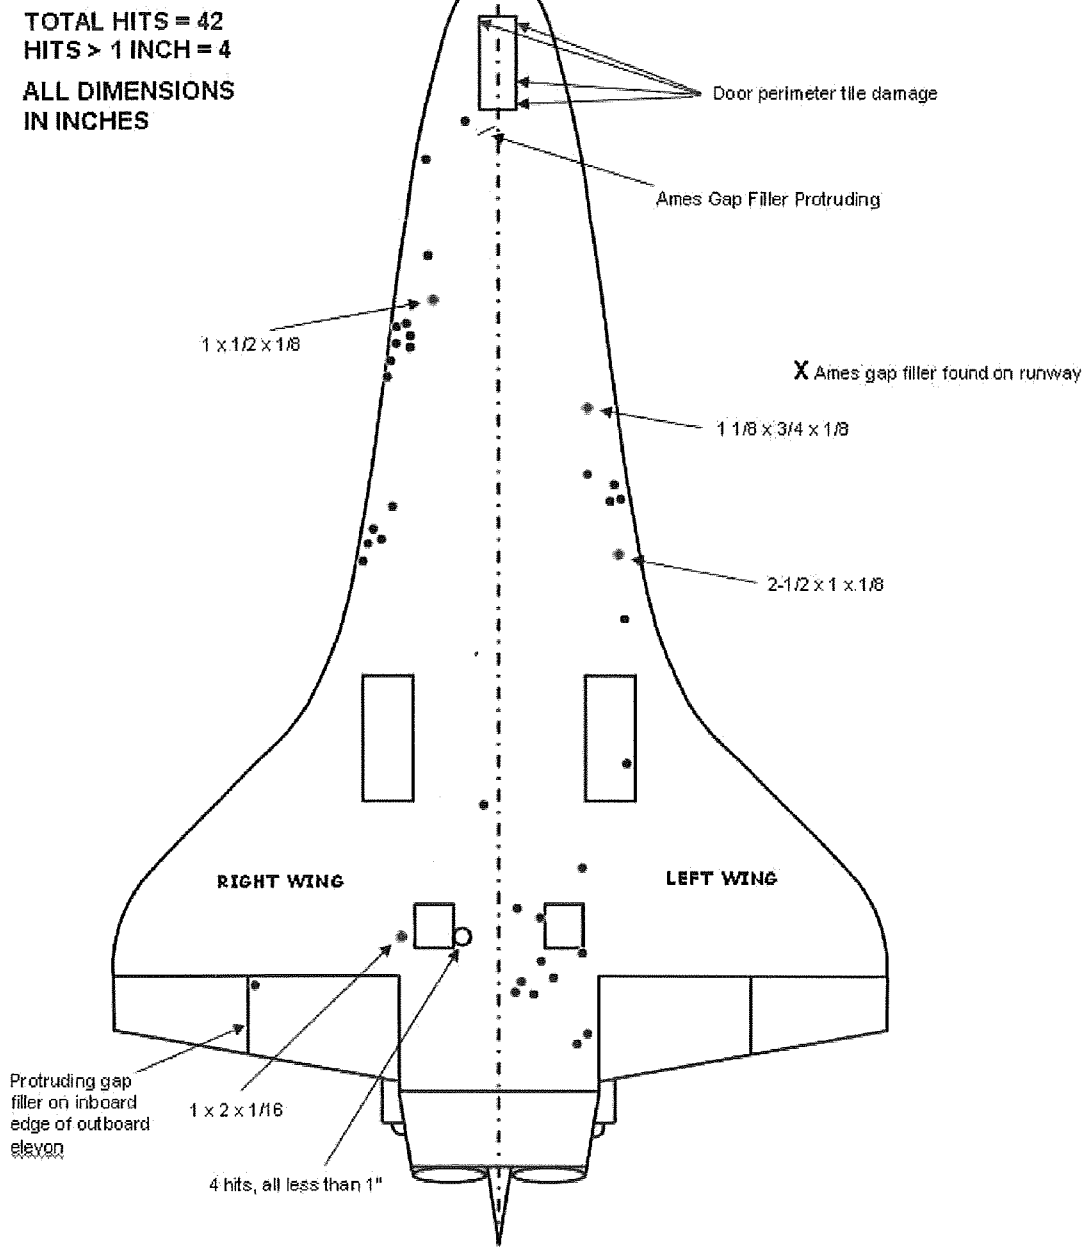
Figure 1: Orbiter Lower Surface Debris Damage Map

TOTAL HITS = 48
HITS > 1 INCH = 8
ALL DIMENSIONS
IN INCHES

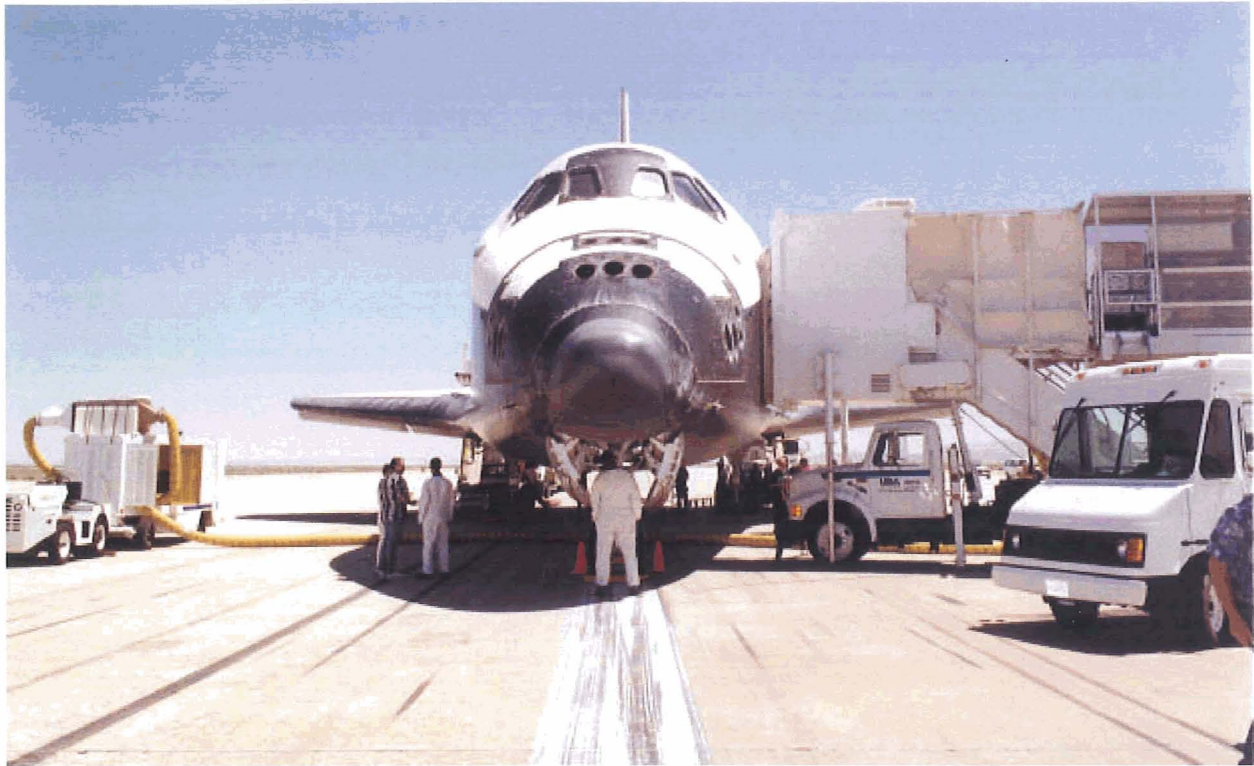
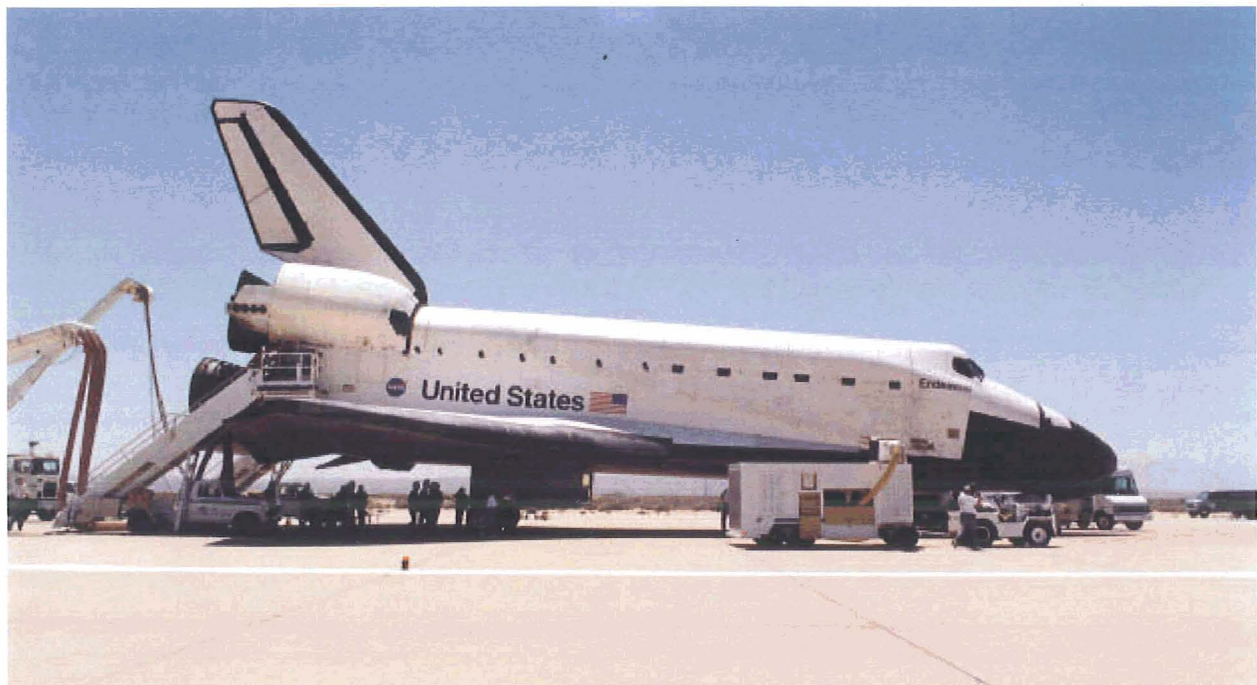
Photo 12: Overall View of Orbiter

The orbiter lower surface sustained only 42 total hits. Both the total number of Orbiter TPS debris hits and the number of hits 1-inch or larger were well within established family.

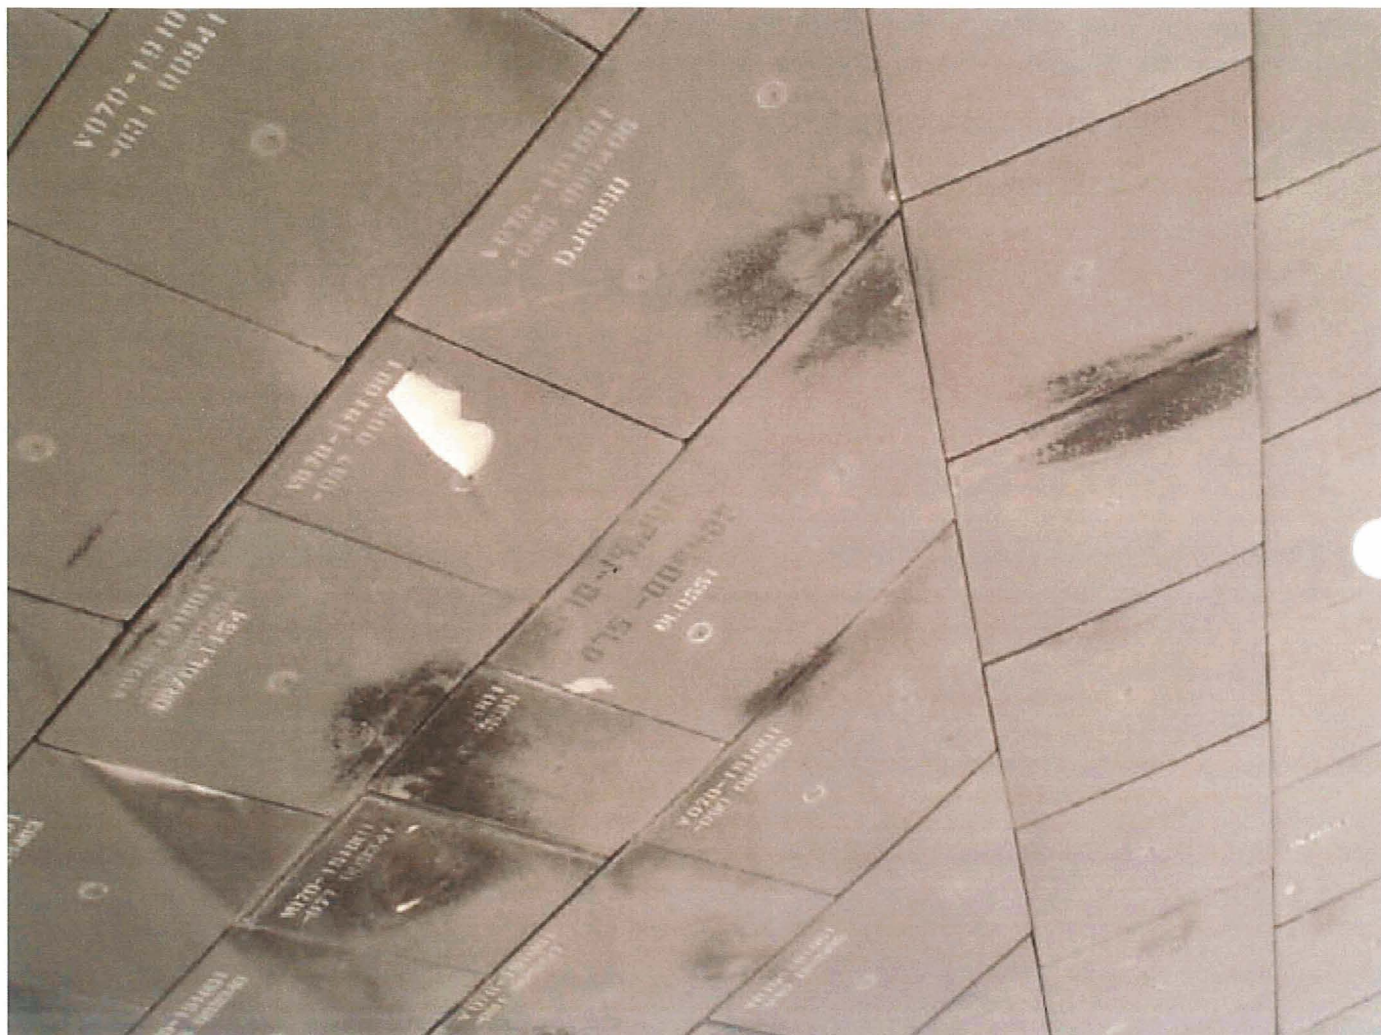
Photo 13: Damage to Lower Surface Tiles

The largest lower surface tile damage was located on the left-hand wing glove forward of the main gear door. This shallow site measured 2.5-inches long by 1-inch wide by 0.125-inch deep, and is probably the result of impact by low density foam material.

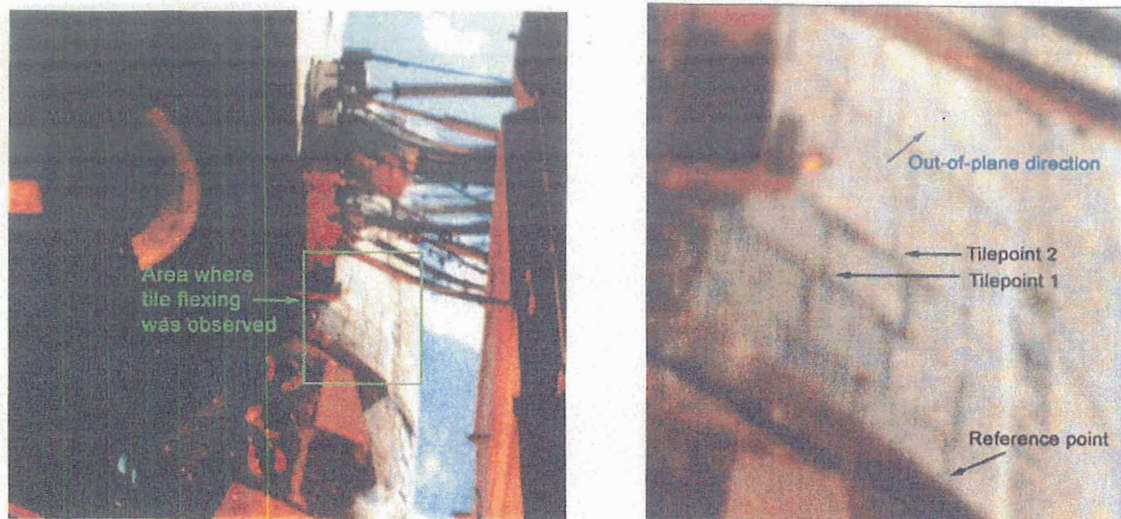
Figure 2.1(A) Camera E18 View of Left OMS TPS Tiles and an Enlarged View of the Area of Interest.

Flexing of the thermal protection system (TPS) tiles on the left (port) OMS thruster pod during STS-100 just prior to liftoff was observed and measured using high-speed motion picture film obtained from camera E18. This flexing was seen at main engine ignition at a time between -3.8 seconds MET and -3.0 seconds MET (18:40:38.2 to 18:40:39.0 UTC). The tiles appeared to bulge outward or pulse rhythmically at high frequency and there was a corresponding increase and decrease in the size of the dark area between some adjacent tiles lying in the center of the region. Similar, but much less dramatic pulsing was seen on the right (starboard) OMS pod tiles from camera E17, an identical camera on the other side of the Orbiter. The view of the right OMS pod tiles contains significant noise and less contrast, and so was not analyzed.

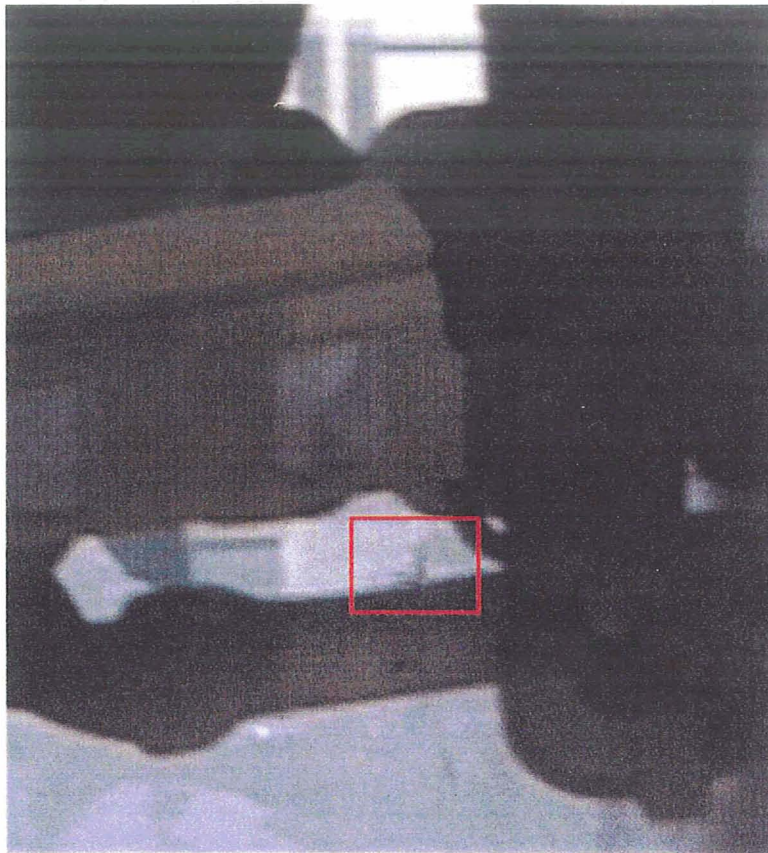
Figure 2.2.1 (C) Ice Debris seen Contacting the LH2 Recirculation Line. (Camera OTV063)

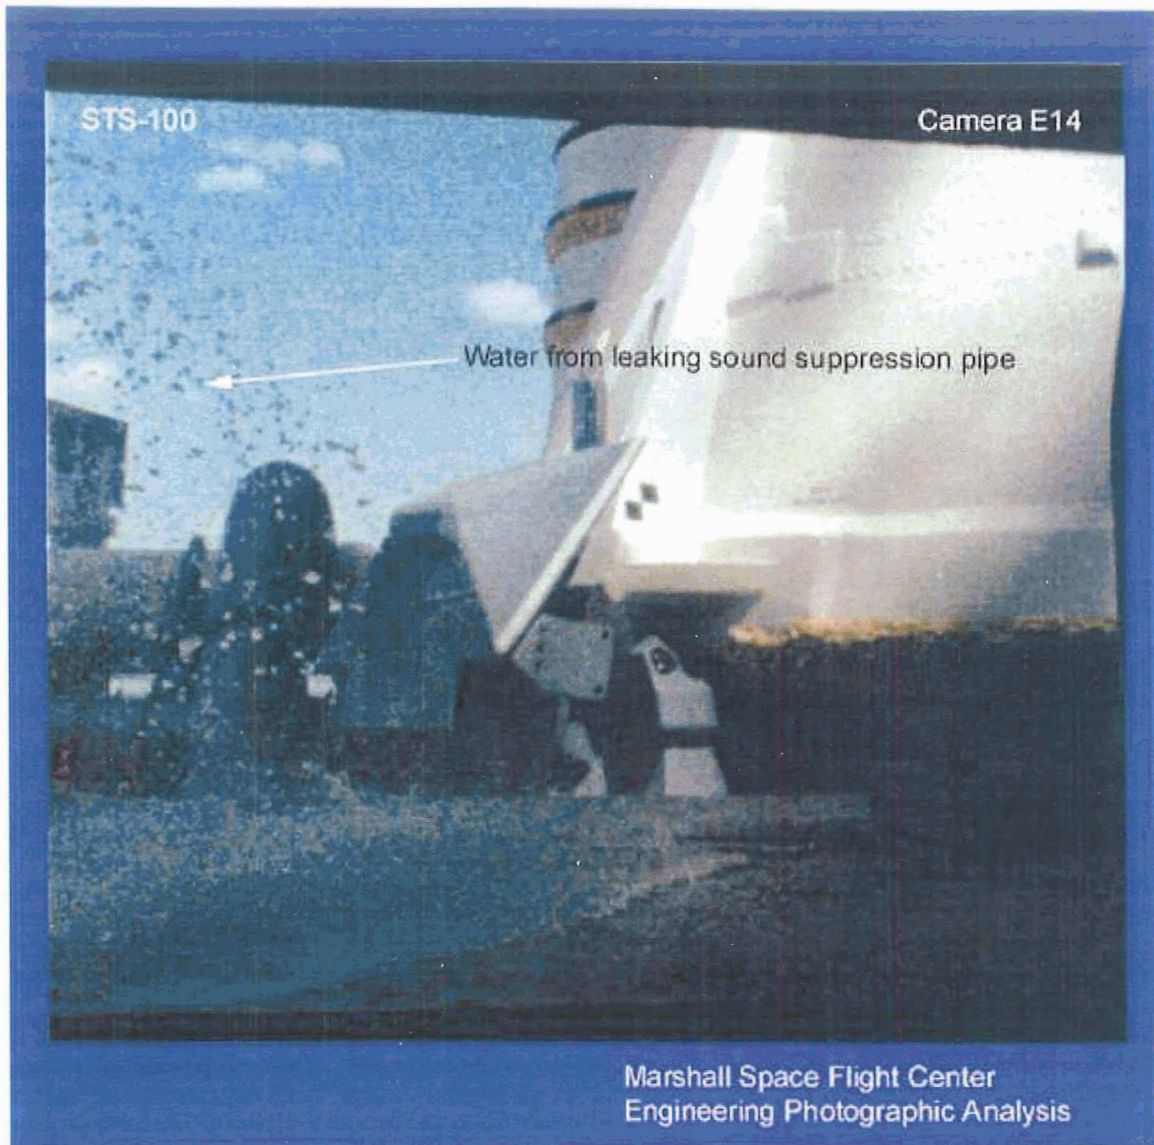
Figure 2. Leaking Water from Sound Suppression System

Water leaking from the sound suppression system near Holddown Post M8 was observed.
